1. Executive Summary [Conclusions and actions]
2. Contract Review
3. Introduction - Purpose, Aims and Objectives
4. Desk Top Review and Survey Planning
5. Survey Method
6. Exclusions and Caveats
7. Sampling and Analysis
8. Survey Results - Interpretation
9. Recommendations

3.3 Type of Survey – Management Survey

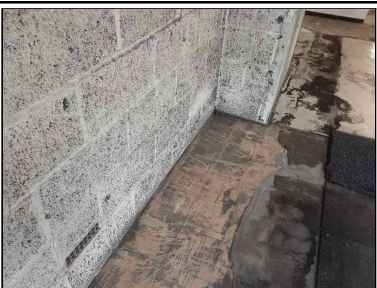
Survey Date:	Lead Surveyor	Survey Type	Floor	Analysis
	17 Apr 2020	Daniel Smith	Management Survey	Ground Floor	Chrysotile (1)
	Building	Room	Item	Quantity	
	derelict ground floor commercial building	shop front G01	floor tiles floor	128m ²	
	Sample No (S,SP,P,As)	Product Type	Surface Treatment	Condition	Accessibility
	AA000070 (S)	Reinforced Composite (1)	Completely Sealed (0)	Low Damage (1)	Occasionally likely to be disturbed
Material Risk Score					
3					
Recommended action	Manage & Label				
Surveyor comments	N/A

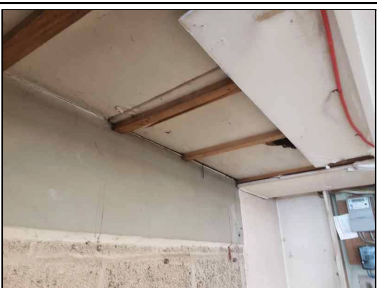
Survey Date:	Lead Surveyor	Survey Type	Floor	Analysis
	17 Apr 2020	Daniel Smith	Management Survey	Ground Floor	No Asbestos Detected
	Building	Room	Item	Quantity	
	derelict ground floor commercial building	shop front G01	fibre board concealed fibre board ceiling	128m ²	
	Sample No (S,SP,P,As)	Product Type	Surface Treatment	Condition	Accessibility
	AA000071 (S)	N/A	N/A	N/A	N/A
Material Risk Score					
N/A					
Recommended action	No further action required				
Surveyor comments	N/A

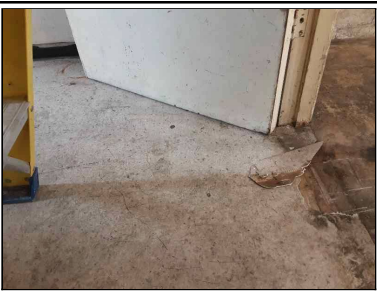
Survey Date:	Lead Surveyor	Survey Type	Floor	Analysis
	17 Apr 2020	Daniel Smith	Management Survey	Ground Floor	Chrysotile (1)
	Building	Room	Item	Quantity	
	derelict ground floor commercial building	kitchen G02	floor tiles concealed floor tiles	3.7	
	Sample No (S,SP,P,As)	Product Type	Surface Treatment	Condition	Accessibility
	As AA000070 (SP)	Reinforced Composite (1)	Completely Sealed (0)	Low Damage (1)	Occasionally likely to be disturbed
	Material Risk Score				
3					
Recommended action	Manage & Label				
Surveyor comments	N/A

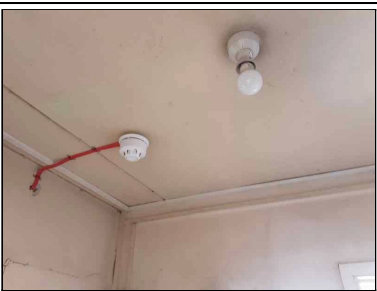
Survey Date:	Lead Surveyor	Survey Type	Floor	Analysis
	17 Apr 2020	Daniel Smith	Management Survey	Ground Floor	No Asbestos Detected
	Building	Room	Item	Quantity	
	derelict ground floor commercial building	kitchen G02	fibreboard ceiling	3.6	
	Sample No (S,SP,P,As)	Product Type	Surface Treatment	Condition	Accessibility
	AA000072 (S)	N/A	N/A	N/A	N/A
	Material Risk Score				
N/A					
Recommended action	No further action required				
Surveyor comments	N/A

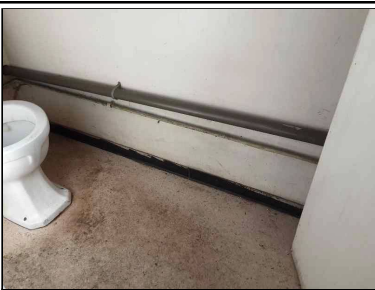
Survey Date:	Lead Surveyor	Survey Type	Floor	Analysis
	17 Apr 2020	Daniel Smith	Management Survey	Ground Floor	Chrysotile (1)
	Building	Room	Item	Quantity	
	derelict ground floor commercial building	W/C G03	concealed floor tiles floor	1.8	
	Sample No (S,SP,P,As)	Product Type	Surface Treatment	Condition	Accessibility
	As AA000070 (SP)	Reinforced Composite (1)	Completely Sealed (0)	Low Damage (1)	Occasionally likely to be disturbed
	Material Risk Score				
3					
Recommended action	Manage & Label				
Surveyor comments	N/A

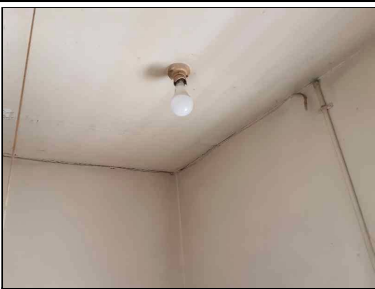
Survey Date:	Lead Surveyor	Survey Type	Floor	Analysis
	17 Apr 2020	Daniel Smith	Management Survey	Ground Floor	No Asbestos Detected
	Building	Room	Item	Quantity	
	derelict ground floor commercial building	W/C G03	fibreboard ceiling ceiling	1.8	
	Sample No (S,SP,P,As)	Product Type	Surface Treatment	Condition	Accessibility
	As AA000072 (SP)	N/A	N/A	N/A	N/A
	Material Risk Score				
N/A					
Recommended action	No further action required				
Surveyor comments	N/A

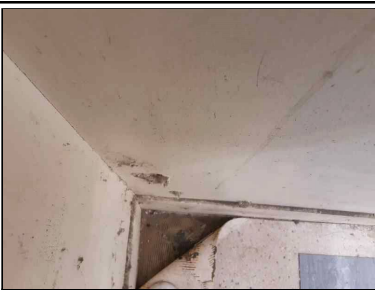
Survey Date:	Lead Surveyor	Survey Type	Floor	Analysis
	17 Apr 2020	Daniel Smith	Management Survey	Ground Floor	No Asbestos Detected
	Building	Room	Item	Quantity	
	derelict ground floor commercial building	store room 1 G04	concealed floor tiles floor	13.5	
	Sample No (S,SP,P,As)	Product Type	Surface Treatment	Condition	Accessibility
	AA000073 (S)	N/A	N/A	N/A	N/A
	Material Risk Score	N/A			
Recommended action	No further action required				
Surveyor comments	N/A

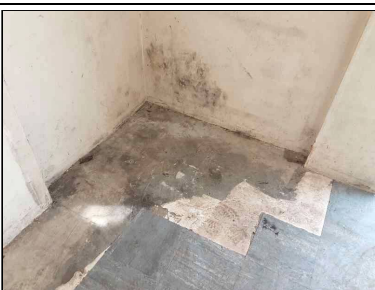
Survey Date:	Lead Surveyor	Survey Type	Floor	Analysis
	17 Apr 2020	Daniel Smith	Management Survey	Ground Floor	No Asbestos Detected
	Building	Room	Item	Quantity	
	derelict ground floor commercial building	store room 2 G05	concealed floor tiles floor	13.7	
	Sample No (S,SP,P,As)	Product Type	Surface Treatment	Condition	Accessibility
	As AA000073 (SP)	N/A	N/A	N/A	N/A
	Material Risk Score	N/A			
Recommended action	No further action required				
Surveyor comments	N/A
