ASBESTOS

CASE STUDY 1

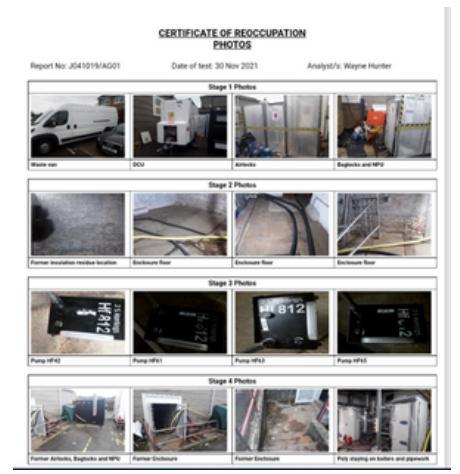
RE-OCUPATION CERTIFICATE

The boiler room was sealed using 1000g polythene to create an airtight enclosure and a Negative Pressure Unit added to Filtrate the air. The Air was change at a minimum rate of 10 times per hour. Walls were scraped and cleaned to remove all visible asbestos residues. All AIB debris was saturated using surfactant and removed using H-Type Vacuums. All walls were encapsulated using White ET150 sealant once checked by an Independent UKAS accredited Analyst. The solid concrete floor was painted using grey suitable floor sealant.

4 Stage Airtest was carried out on completion and a reoccupation Certificate was issued by a UKAS accredited Analyst. The Boiler room is now safe to reoccupy and carry out maintenance works to the boilers / heating system.
